Job Site Observation

Date: Location: Route 000 Task: Road Re-Opening

Crew: Public Works Department

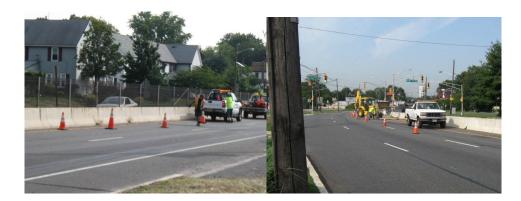
Cone spacing was good and according to MUTCD guidelines, in fact, spacing was closer than required for this roadway. Closer spacing reduces the possibility of vehicles intruding into the work zone.

The work vehicles were positioned behind the cones, with a blocking vehicle between the Backhoe and worksite. The Vehicle was equipped with amber lights.
