LESSONS LEARNED FROM LOSSES

MONTHLY NEWSLETTER – FEBRUARY 2019

Vehicle Maintenance

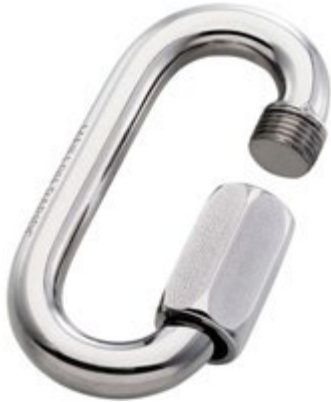
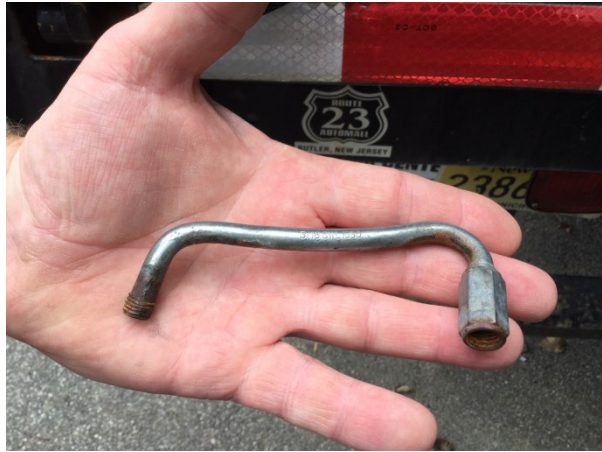
- Employee standing on tailgate of DPW truck when tailgate failed due to rusted quick link clip(see pictures above). The quick link clip was part of the chain existing on each side of the tailgate that kept the tailgate level. The employee suffered multiple leg fractures requiring a lengthy surgery and recovery. The total incurred on the claim is \$124,000. The quick link clip in this case costs approximately \$8.00

- Regular inspections and maintenance should be completed per manufacturer's recommendations.
- Each driver should complete an inspection report of the vehicle prior to each use.
- During inspection, if any items are found to be deficient, the vehicle should be removed from service until repairs are completed.
- All problems should promptly be reported to the program administrator.
